# Rescue Robots at the Collapse of the Municipal Archive of Cologne City: a Field Report

**Abstract** — This paper presents a field report and summarizes the problems of the appliance of rescue robots during the Collapse of the Historical Archive of the City of Cologne. Two robots where on the field, ready to be applied: A shoe-box size tracked mobile robot (*VGTV Xtreme*) and a caterpillar like system (*Active Scope Camera*). Due to the special type of collapse and design limitations of the robots, both robotic systems could not be applied. Either they could not reach/fit into voids or could not be controlled from a safe distance. The problems faced have been analyzed and are described in this paper.

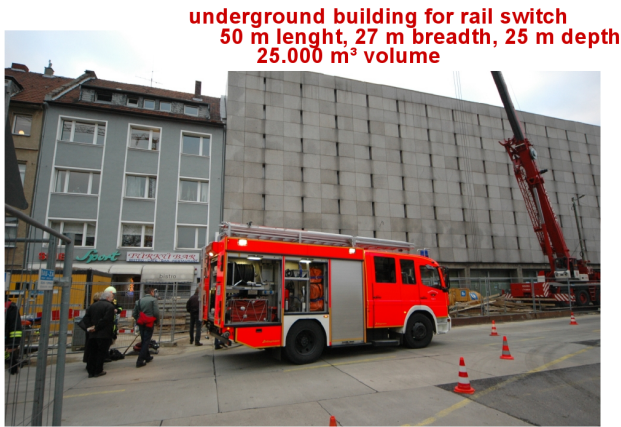
Fig. 2. The rail-switch station and the subway tracks are located below the horizontal concrete paving slabs in front. This picture has been taken four weeks before the collapse [1].

In front of the archive is a construction site for new subway tracks (see Fig. 2). In particular, a rail-switch station was planned to be built below street level next to the archive building. The construction site reaches down 28 m and has three

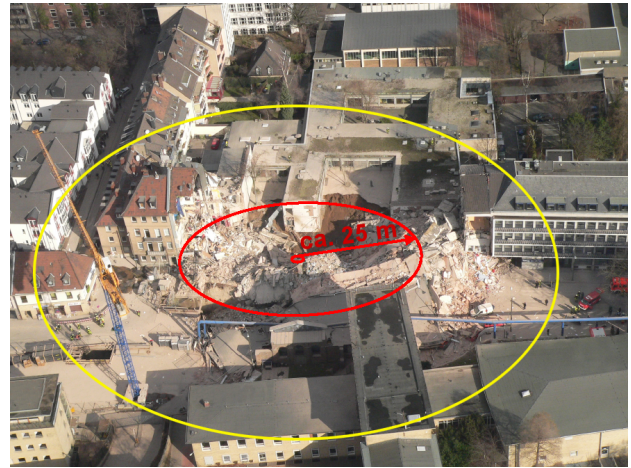
Fig. 3. Aerial view of the scenery on arrival of the first rescue units. The red circled area shows the "hot zone" with a pit diameter of about 25m [1]. The yellow circled area shows the restricted access area only for rescue personnel.

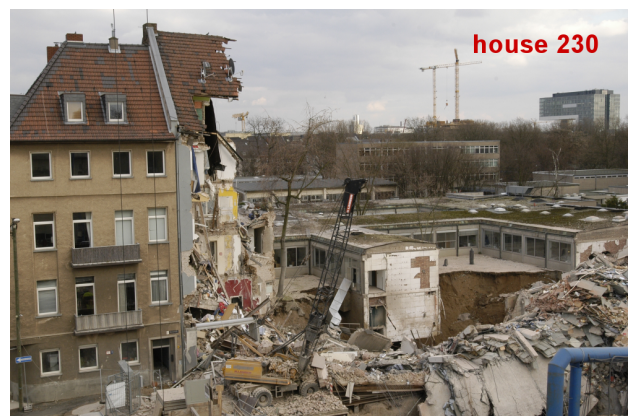
Fig. 5. House 232 (left) and the ruins of house 230 (middle) where the two victims lived in and the ruins of the archive (right) [1].

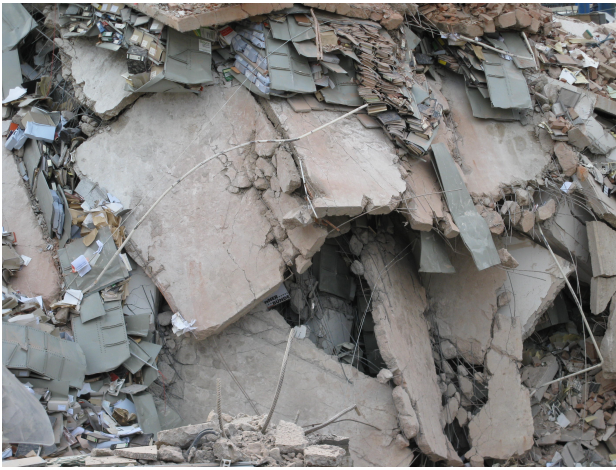
Fig. 6. Mixture of debris. It is composed of ferro-concrete, concrete and bricks of walls, as well as interjacent shelves and historical documents. As shown, there are hardly no voids, where possible victims could have survived [1].

As already mentioned, the archive had been built of ferro-concrete and bricks. The debris, resulting from its collapse, including kilometers of book shelves, did not reveal larger voids. The space that needed to be searched was not been directly accessible. Furthermore, directly standing near the gaps, as well as moving over the debris, could have caused further avalanche-like collapses. None of the three collapsed building structures distinguished in [8], i.e. *pancake*, *lean-to* and *v-shape* collapses, adequately describes the collapse of Cologne's municipal archive.

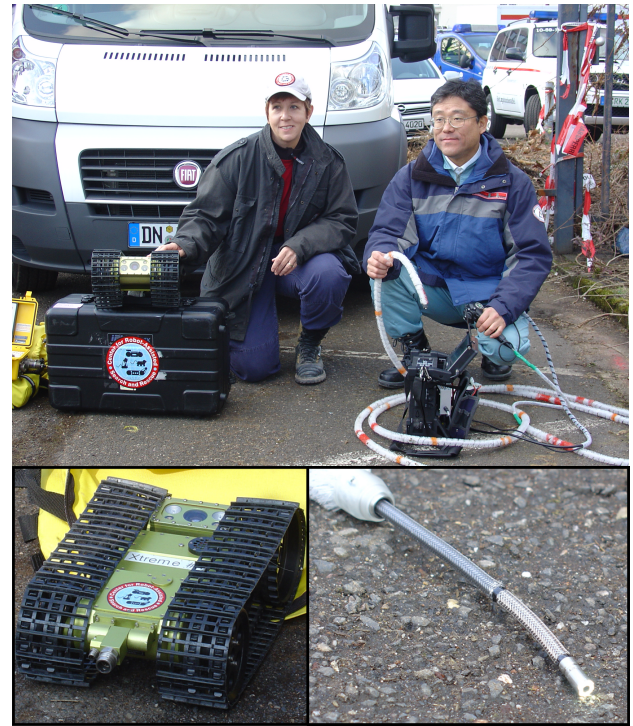
Fig. 7. On the left side Dr. Robin R. Murphy with the *VGTV Xtreme* and on the right side Dr. Satoshi Tadokoro with the *Active Scope Camera (ASC)*.

Two teleoperated rescue robot systems were intended to be applied at the Cologne disaster: A *VGTV Xtreme* and an *Active Scope Camera (ASC)*. The *VGTV Xtreme* is a tracked robot, manufactured by Inuktun Services. It has the ability to change its shape by tilting the front axle up or down [4]. It has dimensions of  $427 \times 277 \times 140$  mm (L×W×H) in the lowered configuration and  $216 \times 277 \times 343$  mm (L×W×H) in the raised configuration. The weight is approximately 6 kg. It is steered via a tether which can be up to 90 m long. The front is equipped with a tilt able color camera and lights [5].

The *Active Scope Camera* is a caterpillar like system. It enhances an industrial scope camera with the ability to move forward and change its direction. The movement force is generated with the help of vibrating inclined cilia. The maximum speed is 47 mm/s and the operating range is 8 m. With its small diameter of less than 30 mm, it is able to search for victims in rubble with small voids [6].

Both robot systems are depicted in Figure 7.

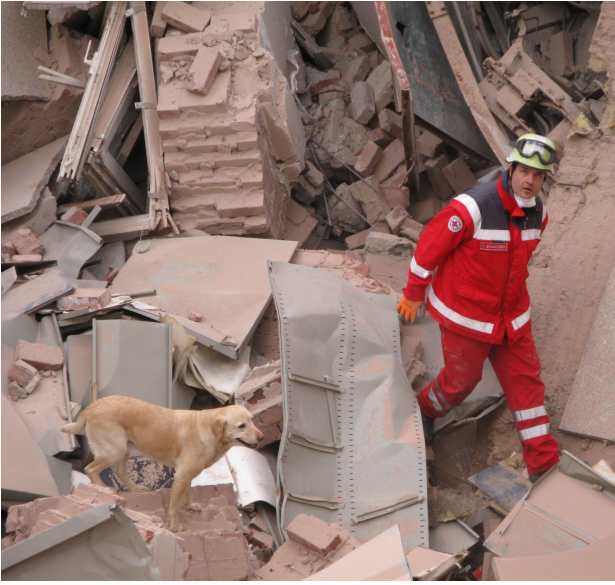
Fig. 8. A rescue dog is guided over the rubble to search for victims.

- 1) A layer of rubble is excavated.
- 2) Two rescue dogs examine the cleared area (see Figure 8).
- 3) If one of the dogs indicates a possible victim, a bio-radar is applied to be able to detect the heart beats of people. If it proves the dog's perception of a living person, one of the rescue-robots can be applied. The robot's task is to investigate the health status and how the survivor can be rescued best. With the acquired information, excavation can be performed more precisely while reducing the risk of further harming victims.

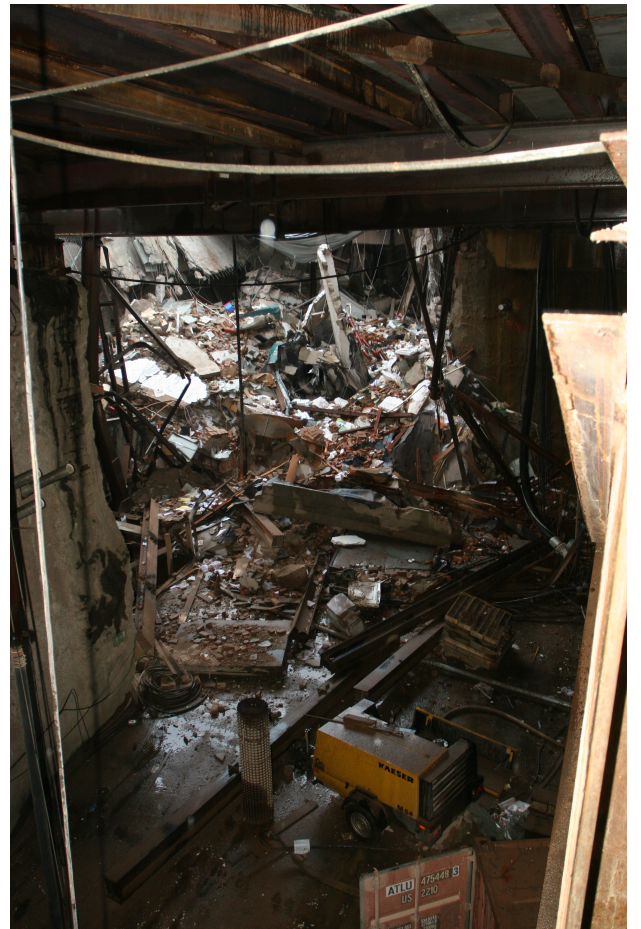
Fig. 10. Subsurface scenery. On the right-hand side the rail-switch is shown. The victims had been expected on the left side, behind the perforated slotted wall. The Active Scope Camera could have been employed in this situation, but the operating area was not safe [1].

In principal, smaller voids could have been inspected using the *Active Scope Camera*. However, due to the fact that directly standing near the point of interest was not possible and that the camera can not be operated remotely, the *Active Scope Camera* could not be applied (see Fig. 10-12). Furthermore, some voids in the upper layers of the debris could not be reached because the *ASC* was missing the capability of getting over larger barriers. Regarding the application of the *VGTV Xtreme*, the debris did not contain voids being large enough for the *VGTV Xtreme* to fit, as was the case in other scenarios: for instance the terrorist bombing attack in Oklahoma City [9], [10]. The combination of rain and brick dust resulted in an extreme slippery ground which made it difficult for man and machines to move around. Having carefully weighed the advantages and risks, the officers-in-charge and the operators agreed not to use the robots.

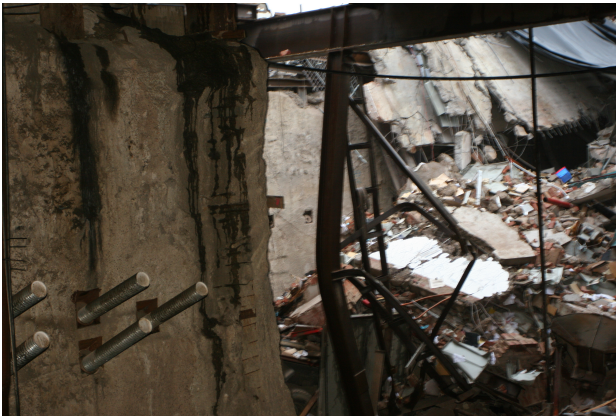
Fig. 11. Bent H-carrier next to the operating area of the Active Scope Camera [1].

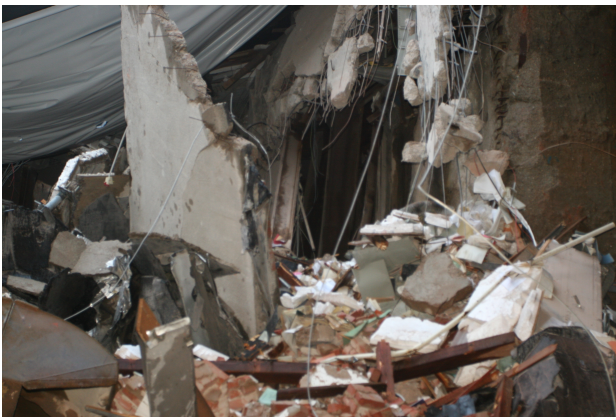
Fig. 12. Detail view of the scene in Fig. 10. What can be seen are so called widow-makers endangering the operators [1].
